IAC-17.B4.3.3

ANALYSIS OF THE COMMUNICATION ANOMALY DURING E-ST@R-2 MISSION OPERATIONS

S. Corpino <sup>a\*</sup>, F. Stesina <sup>a</sup>

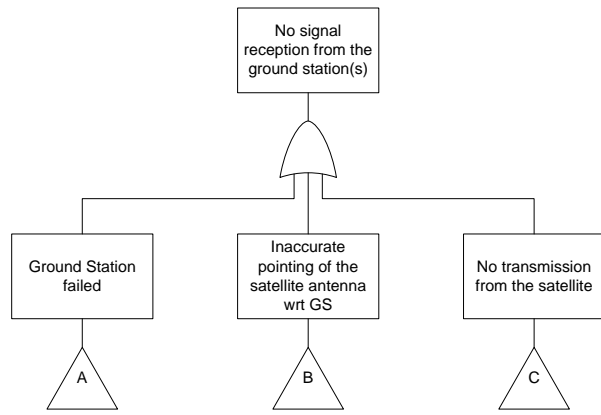
Fig. 3: FT for the top event "No signal reception from the ground station(s)"

The “absence of signal” can be due to Ground station or satellite failures. Single or multiple failure(s) on ground station parts and/or the low performance of some components are considered. Mismatch polarization of the signal (generating a signal attenuation less than 0.3 dB) and the line losses between the antenna and transceiver (generating an estimated signal attenuation of less than 3 dB) cannot justify a loss of signal power so high to cause the complete lack of signal reception. An inaccurate GS antenna pointing provides a signal attenuation proportional to the antenna beamwidth and the actual misalignment of the antennas beams. Considering a beamwidth of 35° for the YAGI antenna and a maximum pointing error of 10°, the attenuation is about 1 dB. Neither this value justifies the complete lack of signal. The 2 meters, 16-elements YAGI antenna provide a theoretical gain of 14 dB: a more performant antenna can contribute to improve the S/N ratio but link margin computation shows that the link should be closed with the gain and beamwidth of this antenna.

The bad pointing of the satellite antenna depends on the velocity of release from the P-POD, environmental conditions (i.e. disturbance torques), and the missed activation of the ADCS or a/more failure(s) of its components. All these conditions affect the satellite attitude. Data analysis of the telemetry confirms that the satellite maintains a slow tumbling motion. The quasi-permanent de-activation of ADCS caused that the release energy from P-POD and/or the kinetics energy due to antenna deployment was not dumped and the satellite tumbles. Moreover, satellite remains under the disturbance torques effects without control. As a consequence, bad pointing of the satellite antenna generates a signal attenuation, determined through equation  $L_{pr} = \left( \frac{\text{pointing error}}{\text{beamwidth}} \right)^2$ . Knowing that a dipole beamwidth is about 160°, Table 2 shows how a high misalignment generates a high attenuation that can both prevent the reception of the signal on ground (if the antenna has a pointing close to the zenith) or reduce signal strength avoiding an efficient decoding process.

moment so that this cause is excluded. On the contrary, it is possible that the satellite cannot transmit because a failure in the transmission chain components (such as antenna, HPA or TNC) occurs. It could be not excluded that TNC could temporary fail in hardware or in software. A HPA failure is hard to investigate due to the limited information about the design of the COTS radio-module from the datasheets.
